Rio Nuevo North

Buried Landfill Delineation with IP

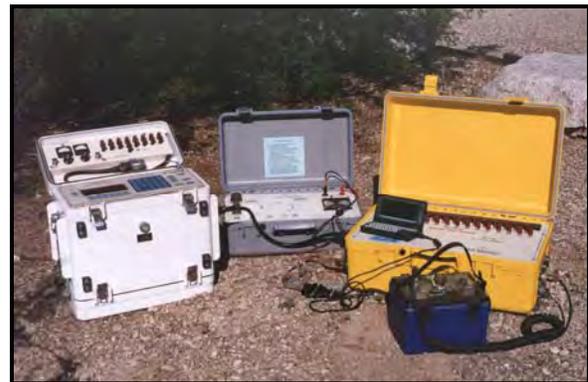
Zonge minimized expenses by utilizing the MX-30 which is a computer-controlled switching interface between a resistivity transmitter, a multi-channel receiver such as the GDP-32, and an array of up to 30 electrodes. All data were acquired in the dipole-dipole configuration with a station-spacing of 7.5 feet and a dipole size of 15 feet. Twelve points were collected along each diagonal ($n=0.5, n=1.0, \dots, n=6$). The electric-field signal was sensed at the receiver site using tin-coated copper braid electrodes. A time domain, 0.5 Hz signal was used, stacking and averaging eight cycles to minimize random noise. All data points were measured at least twice to establish repeatability. A crew of three can acquire 3300 data points plus repeats in one day (2500 linear feet).

ZETA System: GDP-32, MX-30 and ZT-30

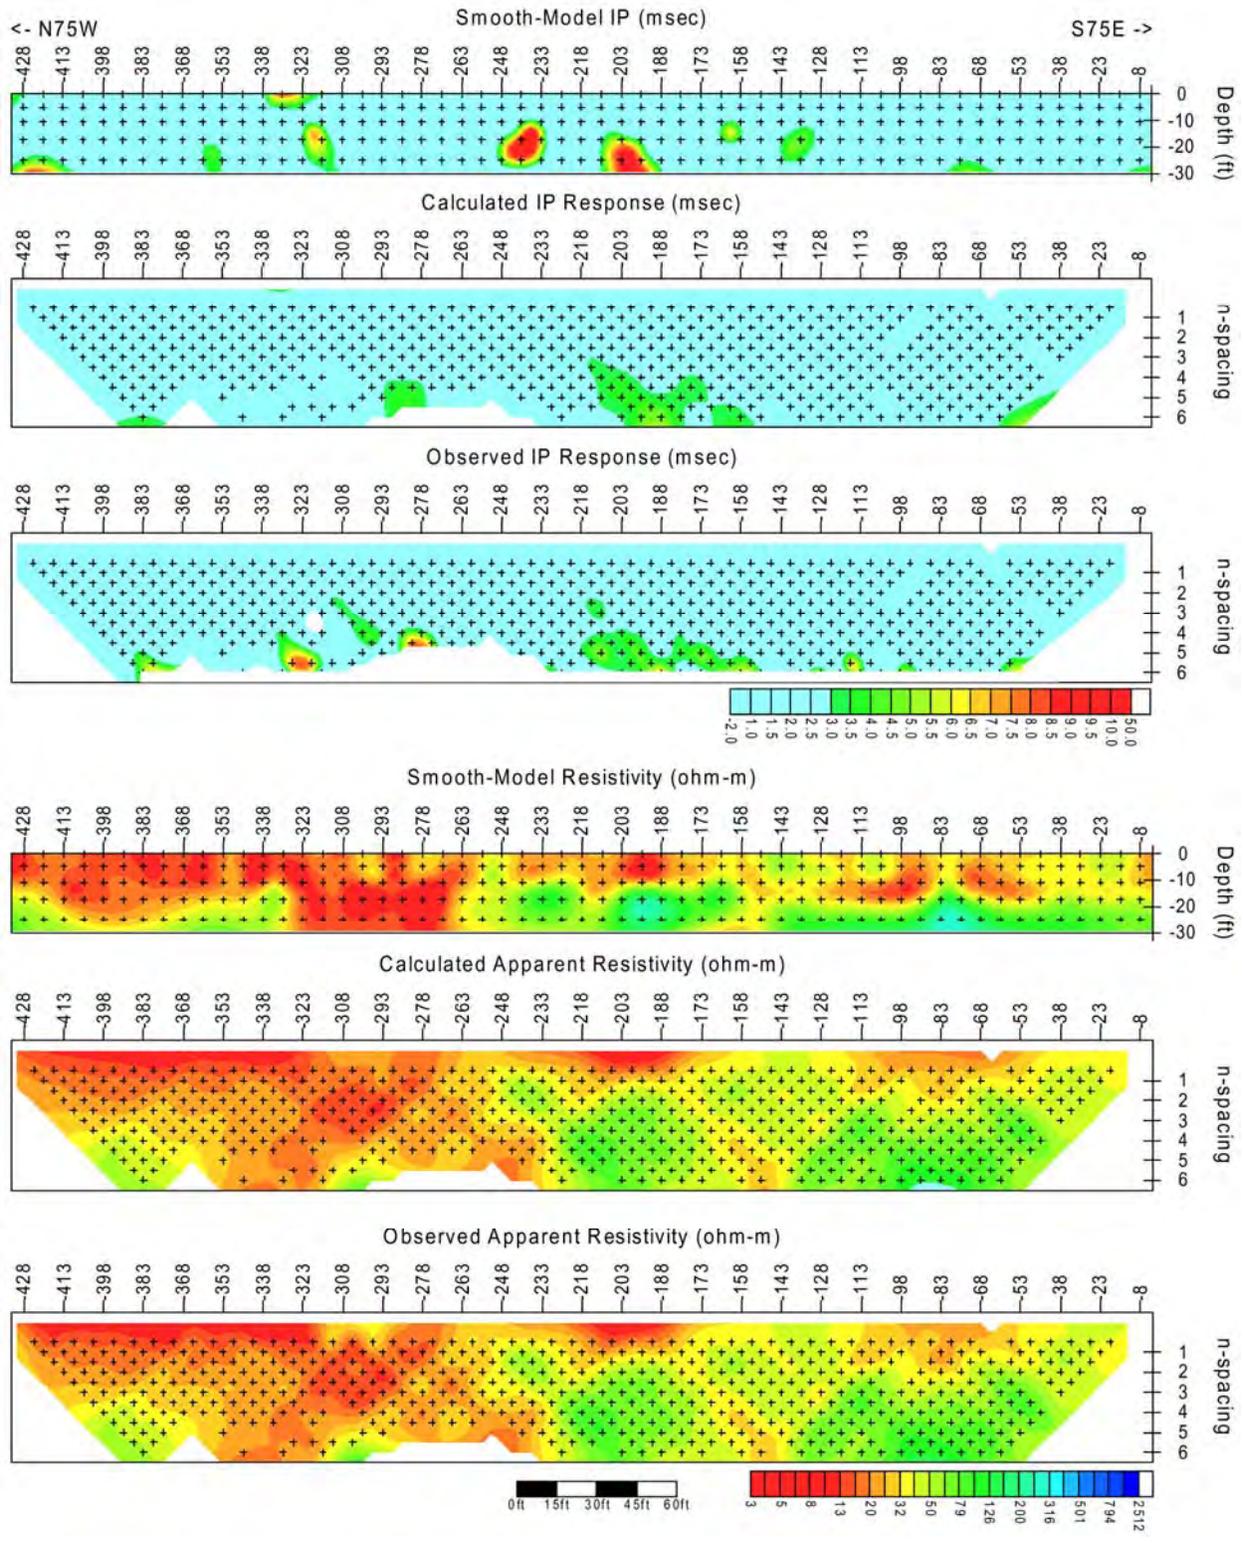
Modeling the survey data consisted of a two dimensional smooth-model technique with topographic compensation. The resistivity and IP phase responses, as a function of n-spacing, are converted to a two-dimensional model of the electrical structure, as a function of depth. The results of modeling create a realistic geo-electric cross section that allows for the interpretation of the edges of buried landfills, thickness of soil cover, and thickness of waste material.

An IP anomaly interpreted as the result of possible waste, centered approximately below station -203, was drilled. Green waste, textiles, and miscellaneous municipal waste were encountered beginning at a depth of approximately 17 feet. A second borehole was placed approximately 20 feet south of the line to further test the extent of the waste material. This borehole encountered similar waste materials.

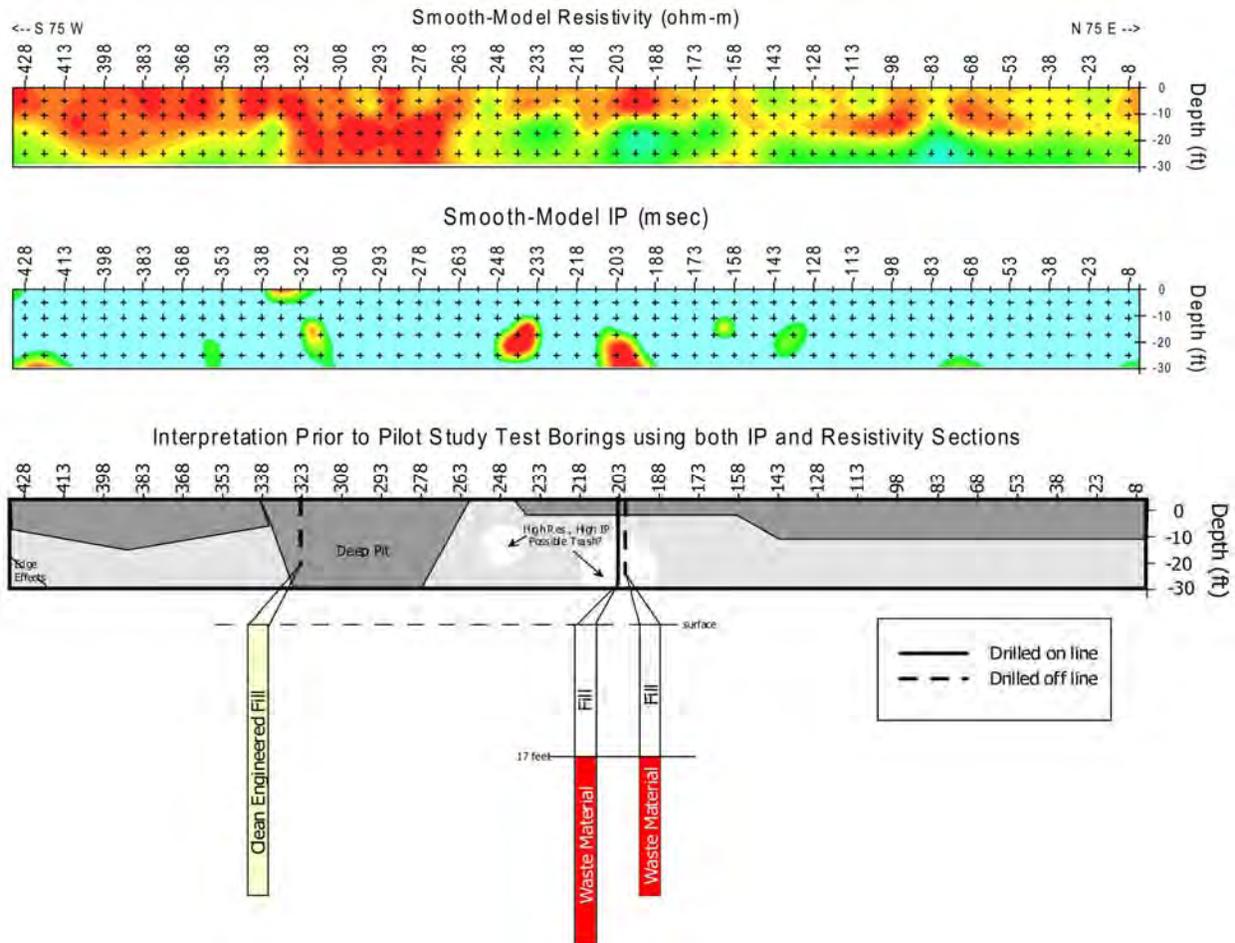
A third borehole was positioned on an area that showed no IP anomaly, but that appeared to be within the historical limits of the depression. This position is characterized by low resistivities, and was interpreted to be a deep pit containing fill material with no waste. The boring recovered clean, engineered fill, primarily of sand and clay.

The excellent correlation between the geophysical survey results from the IP data and the three boreholes provided sufficient reason to expand the survey to include 22 acres within the Rio Nuevo North Resubdivision. Upon completion of the geophysical survey, additional borings were made to aid in interpreting the geophysical data.

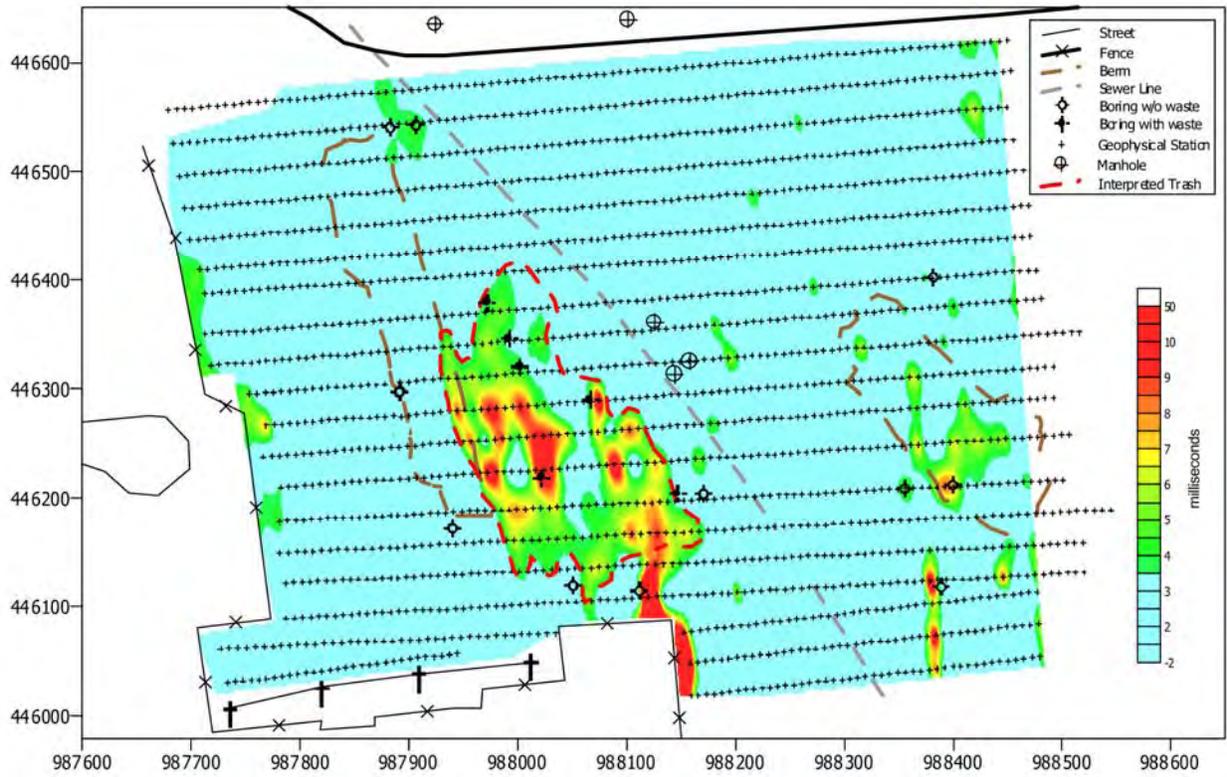
The red dashed line outlines the location of the buried solid waste interpreted from the IP results and boring confirmations. The linear IP anomaly in the lower right corner is thought to be caused by an old utility line (this feature correlates with a dirt road in earlier aerial photographs). The IP anomalies on the western edge of the property are caused by the fence.

Smooth-Model Inversion of IP data at 20 ft. Depth

Only Lots 17 and 18 contain anomalous IP readings that could not be associated with cultural features. Seventeen borings were advanced on the two lots to confirm the IP results. Borings were drilled to test the limits of the garbage, confirm positive IP highs correlating with garbage, and to confirm the absence of garbage in areas without IP highs.

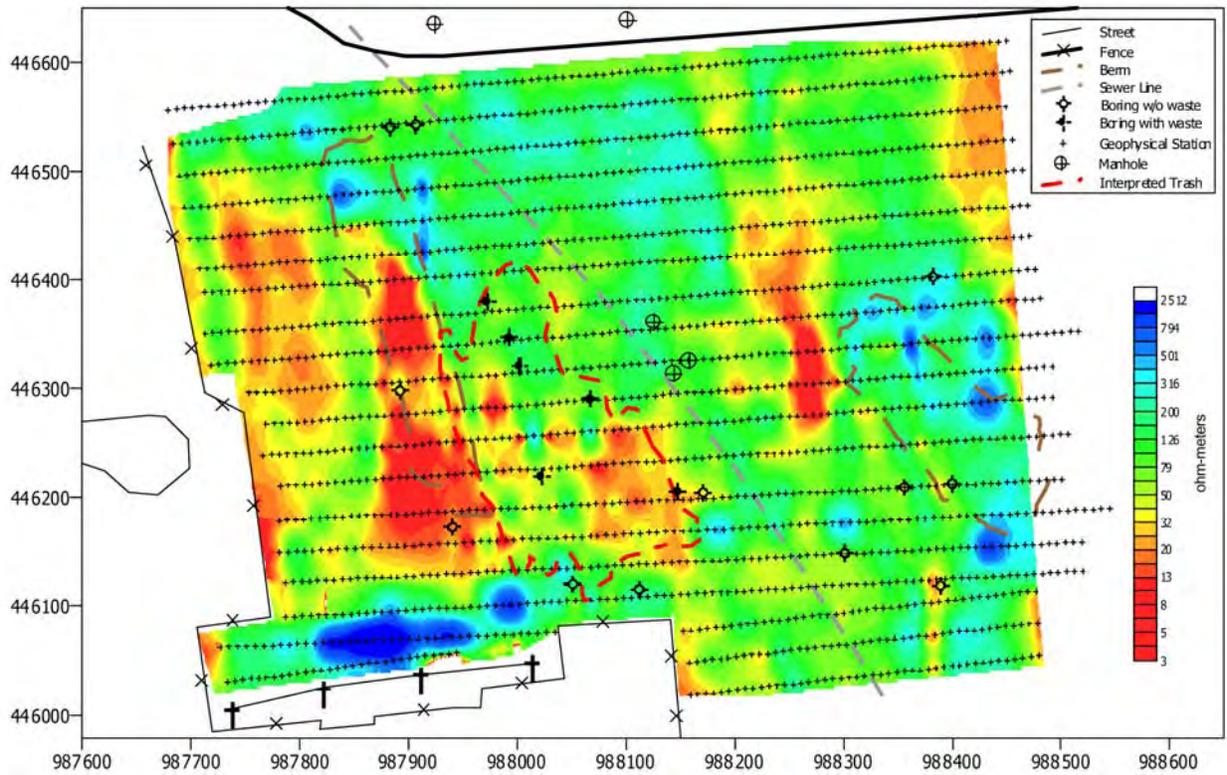
Smooth-Model Inversion of Resistivity data at 20 ft. Depth

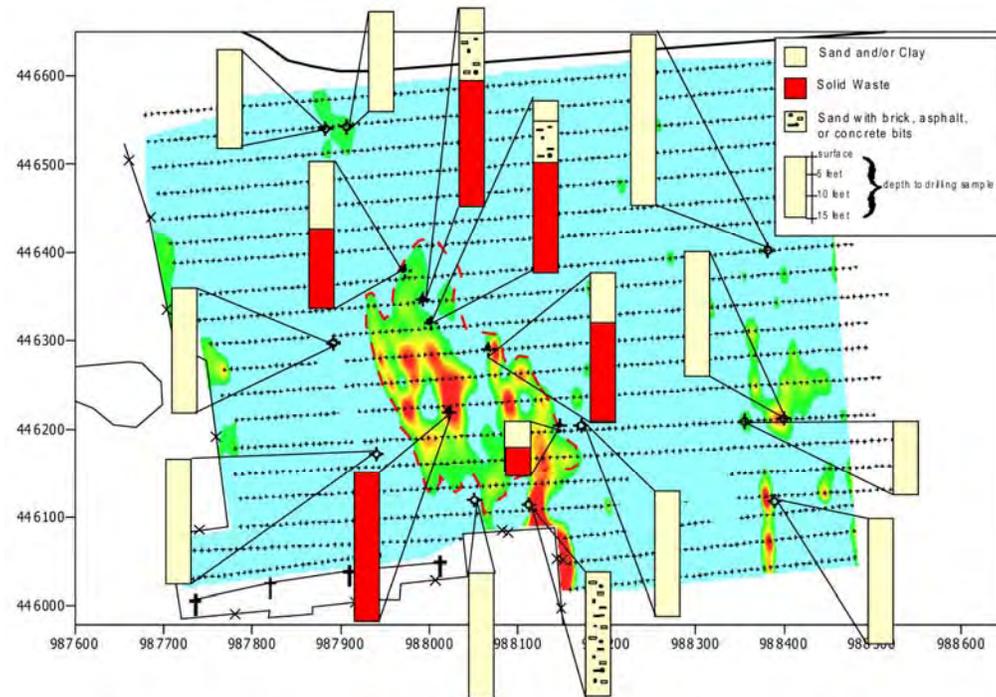
Drilling Results

The drilling results confirm the interpretation of the IP anomalies as waste material. Five borings were placed within the main IP anomaly and all encountered waste material. Three holes were drilled into IP anomalies that did not recover waste material. These areas are thought to contain small amounts of clay, causing IP effects. All borings advanced into background or IP values less than 3 milliseconds did not encounter waste.

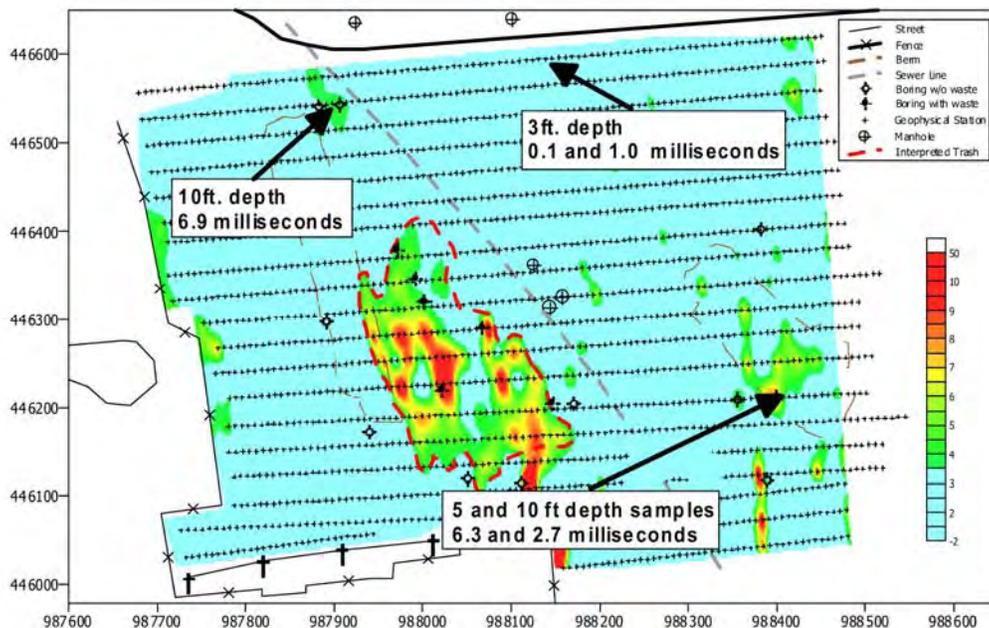
Lab measurements were performed on samples recovered from the areas with IP anomalies but where drilling did not encounter waste material and on several samples taken from an area with background IP responses. The lab measurements confirmed the responses recorded in the field.

Lab Results

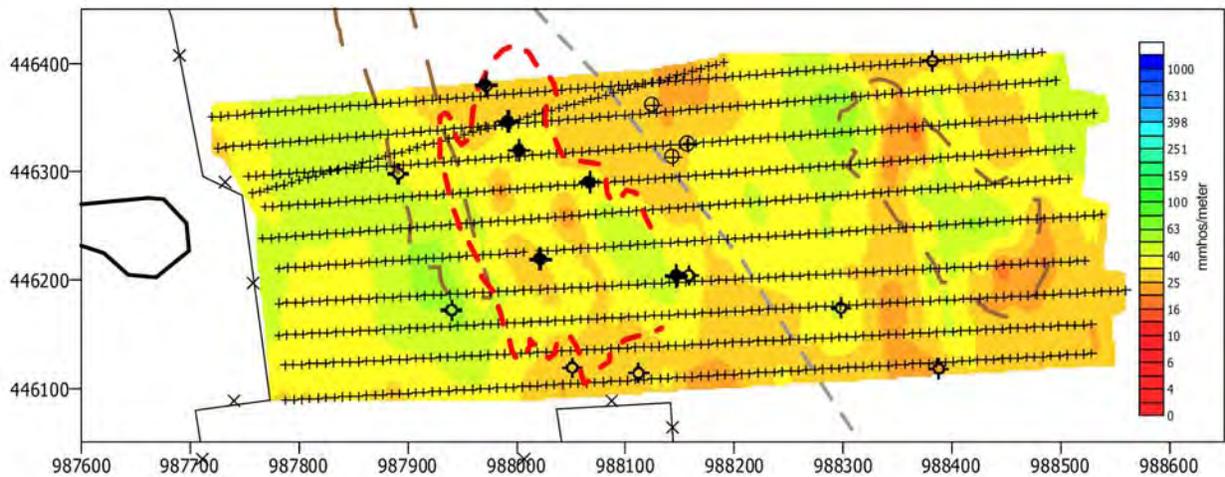
EM-31 Conductivity Data

To test the effectiveness of other traditional techniques in delineating the edge of the buried landfill, an EM-31 and a magnetometer were also run over the portion of the property that contains garbage. The conductivity data from the EM-31 is plotted above. Again, the berms and other features are shown with the data. Note that the data does not show any correlation between the location of the trash and anomalies in the data. The anomalous reading in the magnetics data are mostly caused by surface metallic debris.

It also should be noted that the results from both the EM-31 and magnetics surveys do not offer any vertical information such as depth to garbage and thickness of the landfill.

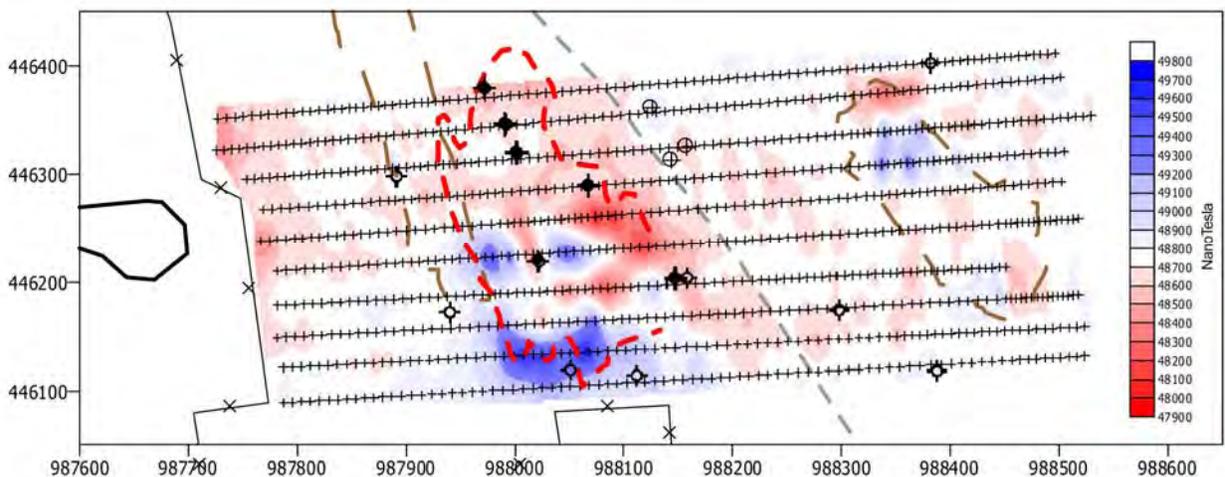
Magnetics Data
