Rio Nuevo North

Buried Landfill Delineation with IP

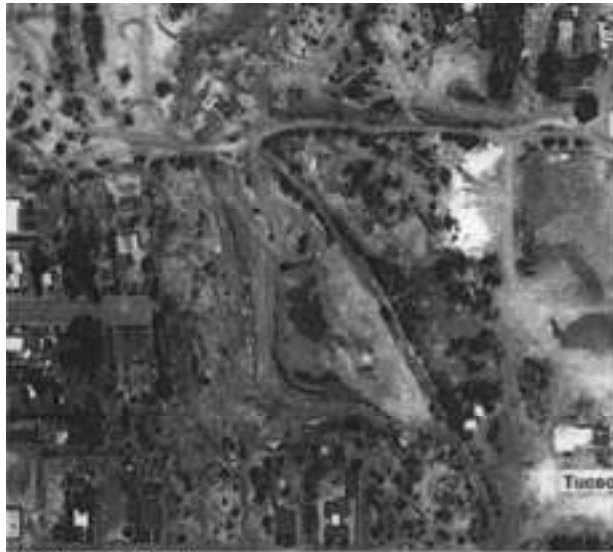
Area photograph from 1953

The aerial photographs above and on the front cover show the same portion of the project area over time. In the 1953 photograph one of the deep pits is evident along with two scarp-like features. Stock piles can be seen covering the surface in the 1973 picture. The cover picture shows the current state of the area; leveled with a couple of berms. The berm on the western edge of the property contains little metallic debris while the berm on the eastern is comprised of concrete with rebar. A few smaller piles of metallic debris and concrete are in the lower mid-western portion of the area.

The location of the test line was chosen primarily on the basis of aerial photographs taken in 1953 and 1967 which showed the presence of a large depression near the center of the line. Though it is not possible to determine from the photographs whether or not waste material was being disposed of in the depression, it was assumed that this was one of the most likely locations for remaining subsurface waste material. Results from the test line and plan views can be seen in the following figures.

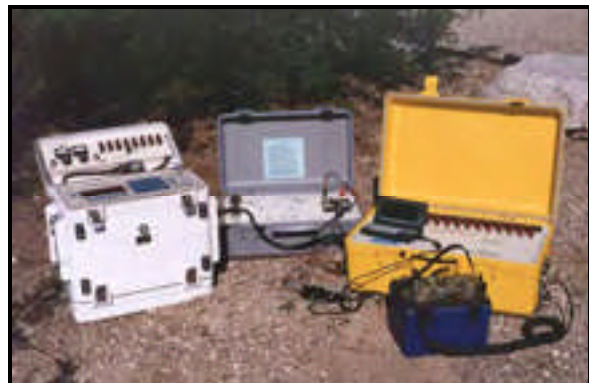
Zonge minimized expenses by utilizing the MX-30 which is a computer-controlled switching interface between a resistivity transmitter, a multi-channel receiver such as the GDP-32, and an array of up to 30 electrodes. All data were acquired in the dipole-dipole configuration with a station-spacing of 7.5 feet and a dipole size of 15 feet. Twelve points were collected along each diagonal ($n=0.5, n=1.0, \dots, n=6$). The electric-field signal was sensed at the receiver site using tin-coated copper braid electrodes. A time domain, 0.5 Hz signal was used, stacking and averaging eight cycles to minimize random noise. All data points were measured at least twice to establish repeatability. A crew of three can acquire 3300 data points plus repeats in one day (2500 linear feet).

ZETA System: GDP-32, MX-30 and ZT-30
